## **Resolution of an Environmental Noise Problem Caused by a 345 KV Power Pole**

David J. Parzych<sup>a)</sup>  
Power Acoustics, Inc.  
12472 Lake Underhill Rd #302  
Orlando, FL 32828

### **ABSTRACT**

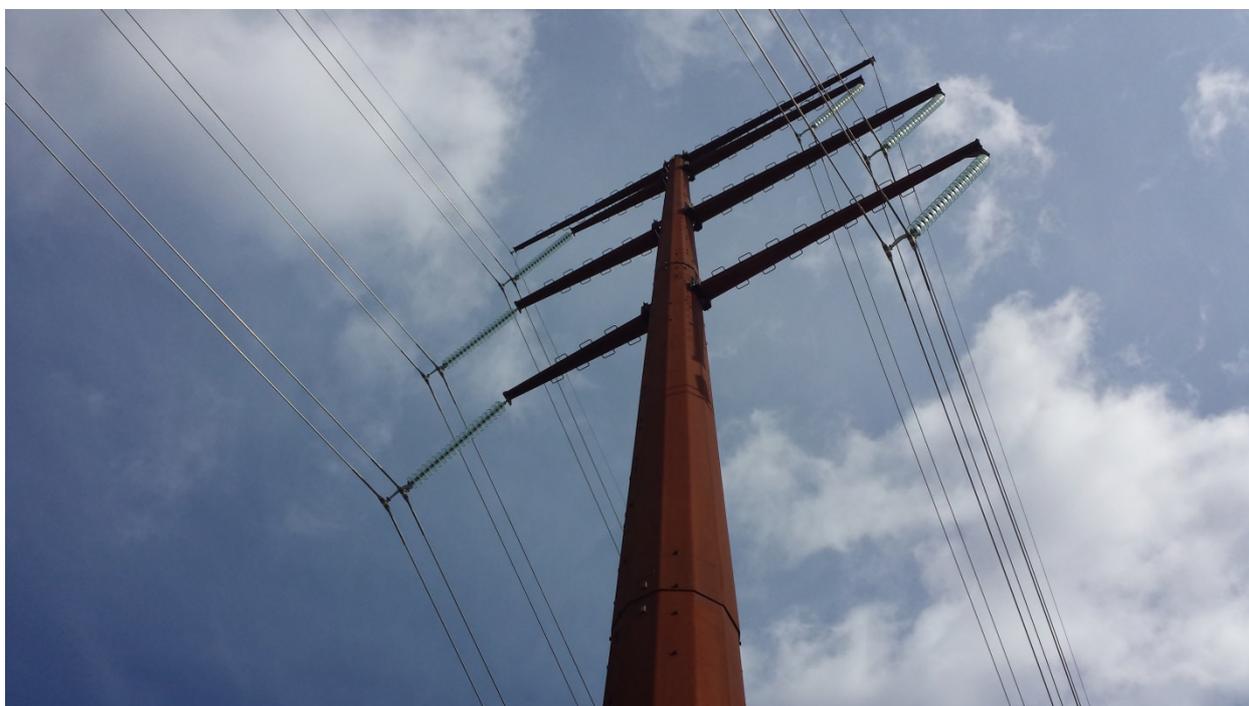
A resident living in a rural area adjacent to recently installed 345 KV power poles similar to the one shown in Figure 1 complained that a particular pole would "sing" during high wind or gusty wind conditions. Strangely, although many hundreds of similar power poles had been installed over an area that spanned over a hundred miles, no other residents living adjacent to poles had complained. It was first assumed that possibly all poles "sing" since the general construction of all poles was similar and maybe this complaint was from a particularly noise sensitive neighbor. But the resident also had exposure to other poles located within several hundred feet of his home that didn't sing. Utility personnel had witnessed the pole's sound which was intermittent in nature and often lasted only a second or two, then disappeared as wind conditions changed.

*Fig. 1 – A 150 foot tall 345 KV power pole*

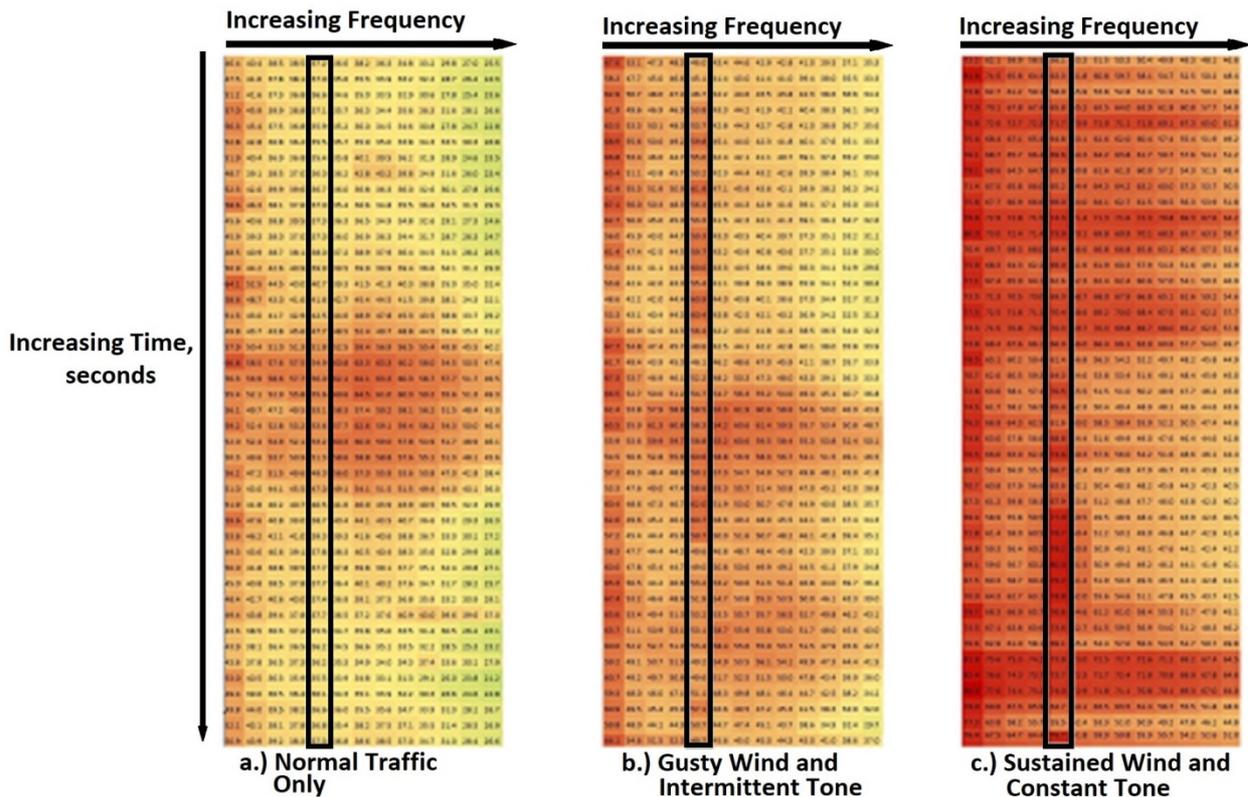
- a) The typical sound from a passing vehicle with no tonal noise present,
- b) Tonal noise is present during a day with gusty wind. Tonal sound comes and goes as the wind speed increases and slows,
- c) Tonal noise is present during a day with sustained high velocity wind. Strong wind related noise and dynamic pressure are also observed.

Fig. 3 – 1/3 Octave Band time histories using MS Excel conditional formatting

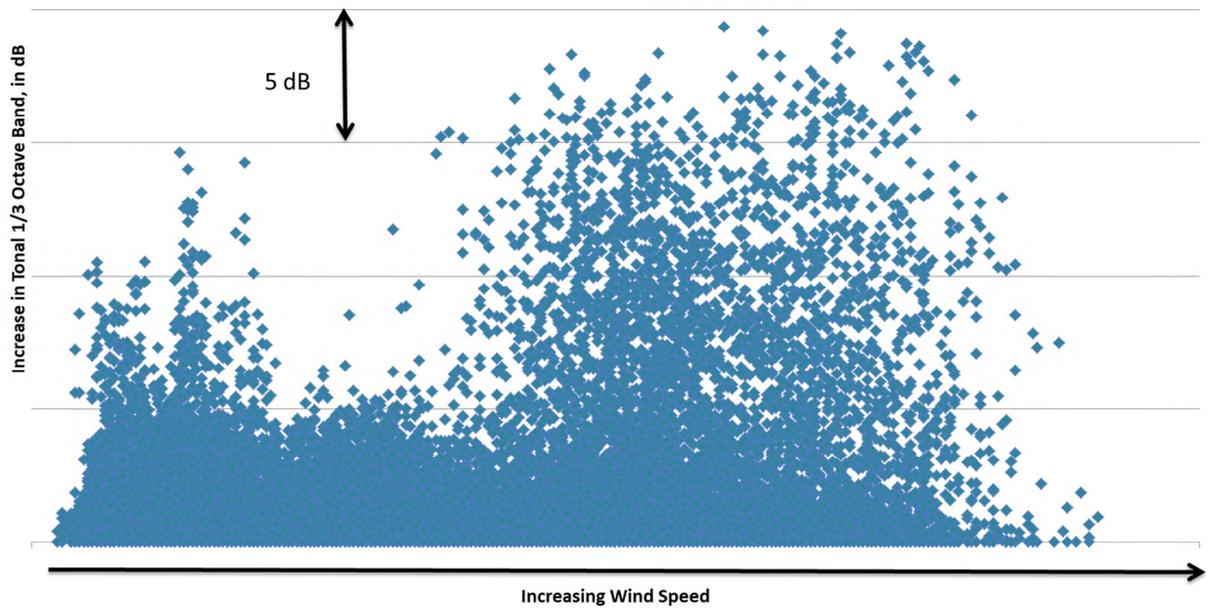
- 1.) Several integer multiples (harmonics) of the fundamental frequency were present when the wind speed was low.
- 2.) A single tone occurred at twice the fundamental frequency when wind was blowing at a high sustained wind speed or during high speed intermittent gusts.
- 3.) The tone occurred consistently when the wind direction was primarily 20-50 degrees from parallel to the pole’s arms. The tone also occurred during variable direction gusty wind conditions so it is unknown if the data was influenced by a sudden change in wind direction. Clearly, the vast majority of tonal noise occurred when the wind direction was not perpendicular or parallel to the arms of the power pole.

*Fig. 4 – 1/3 Octave Band tonal dependence on wind speed*

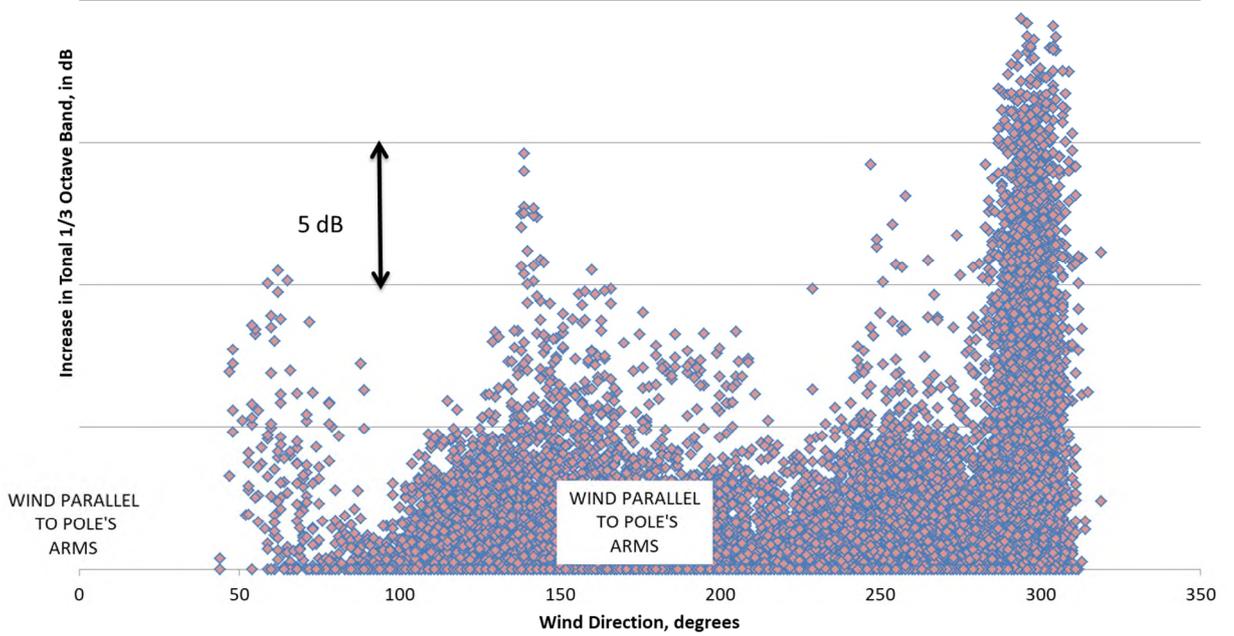
*Fig. 5 – 1/3 Octave Band tonal dependence on wind direction*

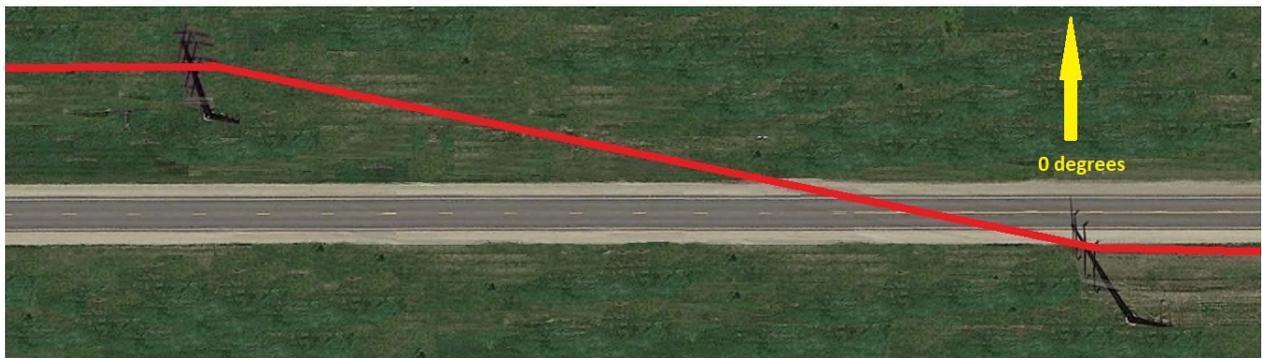
The confusing issue remaining was similar components were used on all poles, but all poles didn't generate tonal noise. So what made the "singing" poles different? Finally a breakthrough; the two poles that were observed to sing were on power poles where the alignment shifted to the opposite side of the road. The alignment change, as shown in Figure 6, proved to be the key to diagnosing the mechanism of the tonal noise.

*Fig. 6 – Power transmission line alignment direction change*

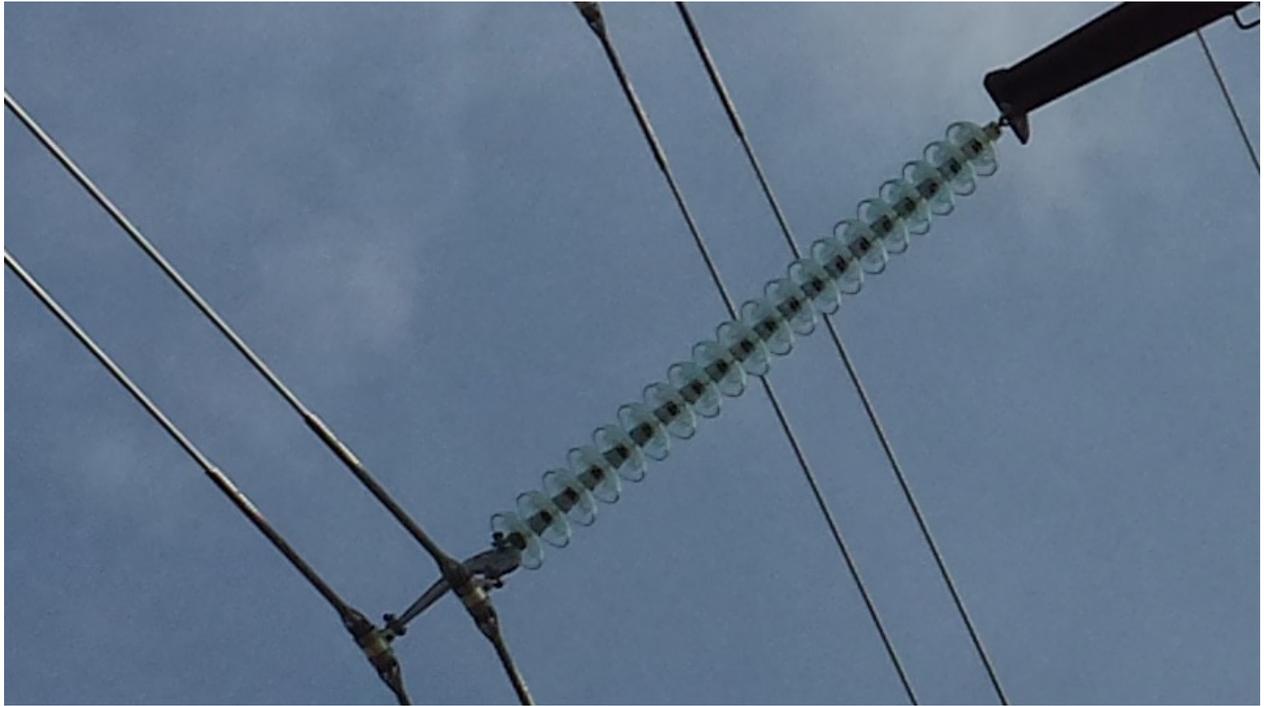
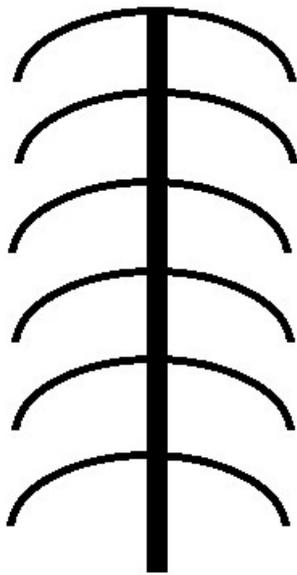
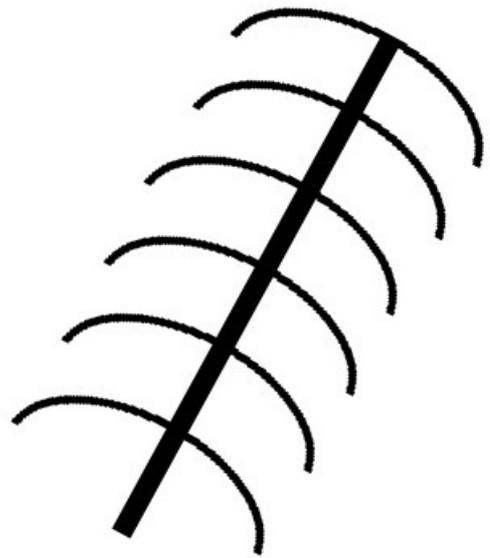
*Fig. 7 – Power transmission line insulator orientation*

When the power transmission line crossed to opposite sides of the road, the insulators, shown in Figure 7, were no longer hanging vertically, but slightly angled into the horizon and wind. Finally, there was a similarity with the poles observed to generate tones that made them unique in configuration compared to the majority of the other poles. Furthermore, the tonal noise only occurred when the wind was blowing into the concave surface or onto the convex surface of the insulators.

**Vertical Orientation of Insulators**

**Orientation of Insulators with Power Line Alignment Change**

While the vast majority of a utility's newly installed 345 KV power transmission lines do not result in noise when the insulators are suspended vertically, a flute-like tonal noise was generated when the insulator's concave or convex surfaces were slightly angled horizontally into the wind. The insulator's orientation is angled toward the horizon at locations where the power line's directional alignment changes.

Discussion with the insulator manufacturer indicated that they were aware of conditions that could cause these particular insulators to create tonal noise. The manufacturer recommended changing the insulator type to a different profile.

At the next scheduled power line outage, the insulators were changed and the tonal noise problem was cured.

Eliminating the tonal noise required changing the insulators on offending power poles to an alternate profile design.
