## **Resolution of an Environmental Noise Problem Caused by a 345 KV Power Pole**

David J. Parzych<sup>a)</sup>  
Power Acoustics, Inc.  
12472 Lake Underhill Rd #302  
Orlando, FL 32828

### **ABSTRACT**

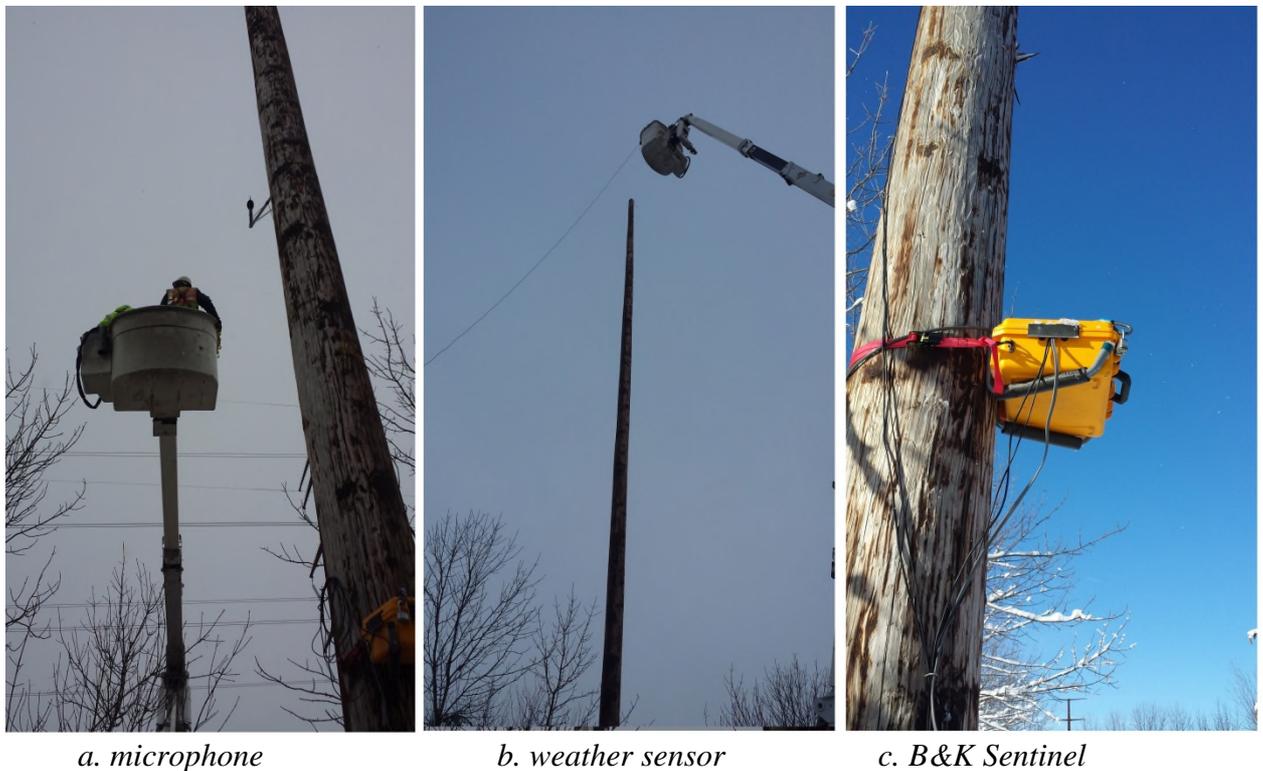
A temporary wooden pole was installed adjacent to the resident's property across the road from the offending 345 KV power pole. The B&K Sentinel sound monitoring system and Vaisala weather station were installed on the temporary pole. Shown in Figure 2 is the installation process including the microphone, the weather station and the packaged Sentinel instrumentation.

*Fig. 2 – Installation of the sound monitoring and weather instrumentation*
